**Flood Control Project Maintenance
Levee Inspections**

Maintenance Issue Types Only, Levee Inspection Report By Mile - Spring 2018

Sutter Maintenance Yard Maintenance Area 0001

Waterway	Bank	Unit Miles	Inspection Start/End	Inspector
Unit No. 01 Sacramento River	Right	16.76	03/06/2018 03/06/2018	Bob Duffey

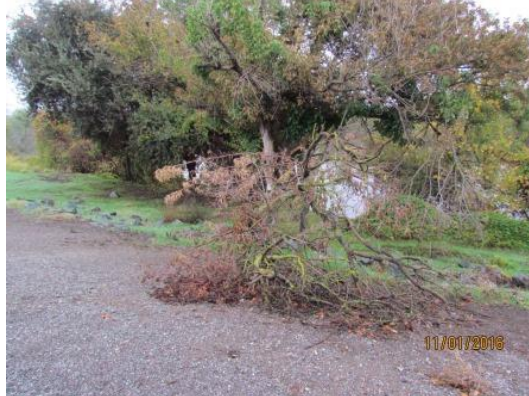
Photo 1 of 1 : SP_2018_MA0001_297_93_20180305_00025.jpg

LM Start	0.07	Rating **	M	Issue No.	93
LM End	0.07	Issue Type +	Ma	Location *	WS
Category	Earthen Levee		GPS Latitude/Longitude		
			Start	End	
Item	Encroachments		39.214162 °	39.214162 °	
			-122.002158 °	-122.002158 °	
DWR ID	DWR_MA0001_01_f_2016_93				
Comment Code					
TR : Tree or limb					
Inspector Comment

View of a tree limb along the waterside slope.

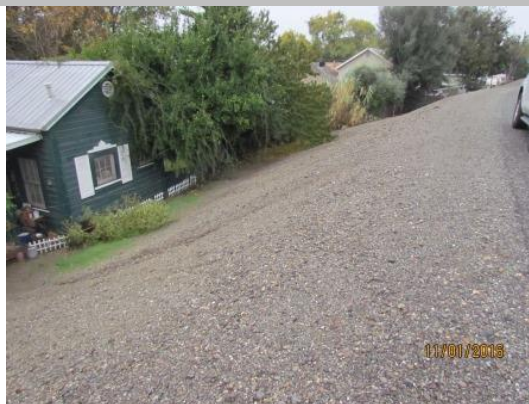
Photo 1 of 1 : SP_2018_MA0001_297_94_20180305_00026.jpg

LM Start	0.09	Rating **	M	Issue No.	94
LM End	0.09	Issue Type +	Ma	Location *	LS
Category	Earthen Levee			GPS Latitude/Longitude	
				Start	End
Item	Slope Stability			39.214217 °	39.214217 °
				-122.002378 °	-122.002378 °
DWR ID	DWR_MA0001_01_f_2016_94				
Comment Code					
S2 : Repair the levee slope damaged by foot traffic and prevent access where possible.					
Inspector Comment					
Repair the erosion along the damaged slope.

View of the slope instability along the landside slope.

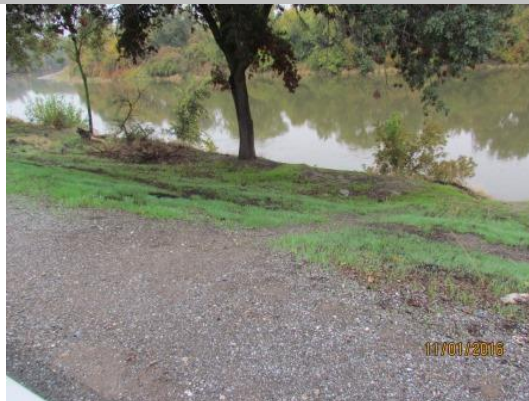
Photo 1 of 1 : SP_2018_MA0001_297_98_20180305_00027.jpg

LM Start	0.38	Rating **	M	Issue No.	98
LM End	0.38	Issue Type +	Ma	Location *	WS
Category	Earthen Levee			GPS Latitude/Longitude	
				Start	End
Item	Slope Stability			39.215878 °	39.215878 °
				-122.007278 °	-122.007278 °
DWR ID	DWR_MA0001_01_f_2016_98				
Comment Code					
S2 : Repair the levee slope damaged by foot traffic and prevent access where possible.					
Inspector Comment

View of the slope instability along the waterside slope.

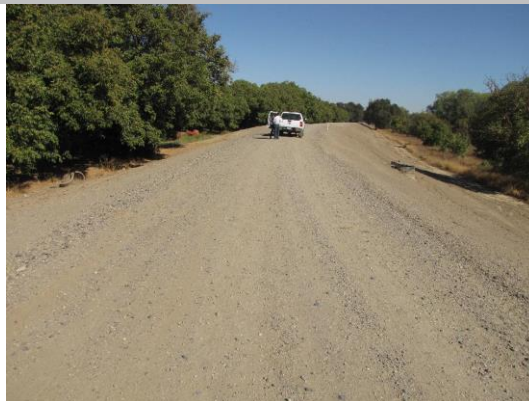
Photo 1 of 3 : UCIP_SP_2018_51852_70064.jpg

FS_ID:51852
DS_ID:16430
EP_NO: 9487
Repair Type: Non-Urgent
Crossing Status: Found
UCIP Comments: 5/3/2017 WS end still partially plugged. (DWR Sutter Yard- AFreitag)10/24/2016 Ws end is till partially plugged.(DWR Sutter Yard- AFreitag)4/25/2016 WS pipe end is still plugged with soil. Rest of the pipe appeared to be in good condition.4/20/2015 WS pipe end is plugged about 50% by soil.6/18/2014 Same as last inspection.12/17/2013 Same as last inspection.7/18/2013 WS pipe end has been reformed but is still clogged about 50% by sediment.10/18/2012 Remove dirt and debris in riser. Outlet deformed and blocked over 50%. Debris-round concrete section on landward side. This crossing was listed in the USACE Periodic Inspections as ID# USACE_CESPK_MA1C_2010_p_0116 for crossing outlet deformed and clogged with dirt.
FIELD_STRUCT_DESC: 1 of 2: 36-inch corrugated metal drainage pipe through the levee, approximately 12-15 feet below the crown. Slide gates in corrugated metal pipe (CMP) riser located on the waterside (WS) slope. Pipe daylights on the landside (LS). (36-inch pipe [HLM 1.97] authorized under Automatic Board Order (ABO) issued as Permit No. 9487, 1974 - Jimeno Rancho) [Additional Reference(s): DWR Levee Log, 1992. USACE Sacramento O&M Manual 137, August 1955, (Station 103+18)].

Overview of levee crown and slopes looking upstream towards crossing.

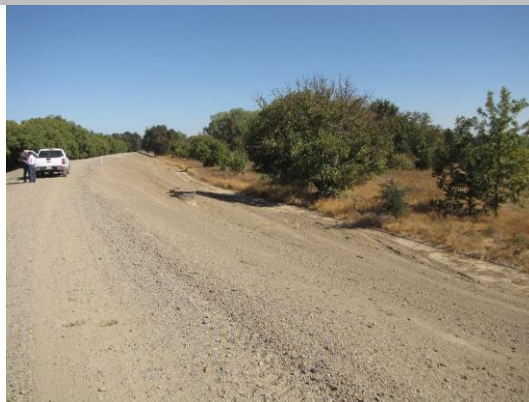
Photo 2 of 3 : UCIP_SP_2018_51852_70063.jpg

View of WS looking upstream at CMP riser on slope.

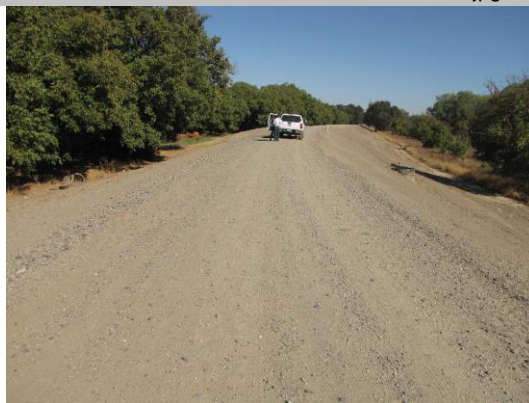
Photo 1 of 3 : UCIP_SP_2018_51853_70071.jpg

FS_ID:51853
DS_ID:17565
EP_NO: 9487
Repair Type: Non-Urgent
Crossing Status: Found
UCIP Comments: 5/3/2017 Ws end still partially plugged. (DWR Sutter Yard- AFreitag)10/24/2016 Ws pipe end still plugged.(DWR Sutter Yard- AFreitag)4/25/2016 WS pipe end still plugged with soil. rest of pipe appears in good condition.4/20/2015 WS pipe end plugged about 50% by soil.6/18/2014 Same as last inspection.12/17/2013 Same as last inspection.7/18/2013 WS pipe end has been reformed but is still partially blocked with dirt and debris.10/18/2012 WS-remove dirt and debris in riser. Outlet deformed and blocked over 50%. Burrow activity near outlet on waterward slope. Debris around concrete section on landward side. This crossing was listed in the USACE Periodic Inspections as ID# USACE_CESPK_MA1C_2010_p_0116 for crossing outlet deformed and clogged with dirt.
FIELD_STRUCT_DESC: 2 of 2: 36-inch corrugated metal drainage pipe through the levee, approximately 12-15 feet below the crown. Slide gates in corrugated metal pipe (CMP) riser on the waterside (WS) slope. Pipe daylights on the landside (LS). (36-inch pipe [HLM 1.97] authorized under Automatic Board Order (ABO) issued as Permit No. 9487, 1974 - Jimeno Rancho) [Additional Reference(s): DWR Levee Log, 1992. USACE Sacramento O&M Manual 137, August 1955, (Station 103+18)].

View of levee crown and slopes looking upstream at crossing.

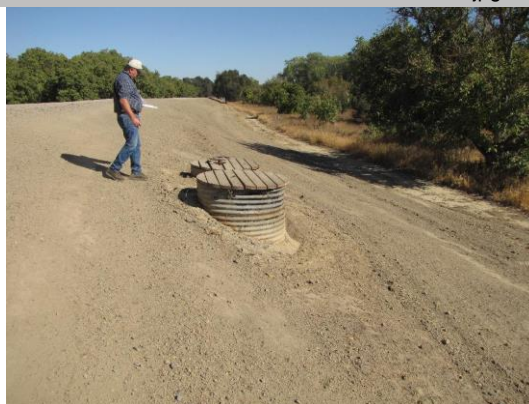
Photo 2 of 3 : UCIP_SP_2018_51853_70074.jpg

View of CMP risers located on WS slope.

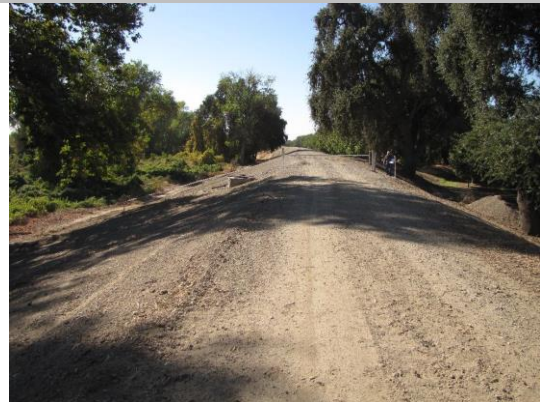
Photo 1 of 3 : UCIP_SP_2018_51854_70078.jpg

Comment Code						
Inspector Comment						
FS_ID:51854 DS_ID:16429 EP_NO: 9472 Repair Type: Non-Urgent Crossing Status: Found UCIP Comments: 5/3/2017 LS inlet partially plugged with soil. Some debris still present inside riser. (DWR Sutter Yard-AFreitag)10/24/2016 Debris still inside of riser.(DWR Sutter Yard-AFreitag)4/25/2016 Pipe still inside of riser and LS end plugged about 50% by soil.4/20/2015 Same as last inspection.6/18/2014 Same as last inspection.12/17/2013 Same as last inspection.7/18/2013 Same as last inspection.10/18/12 Remove debris from riser. Landward inlet is blocked by over 50%. This crossing was listed in the USACE Periodic Inspections as ID# USACE_CESPK_MA1C_2010_p_0128 for sediment build up at inlet (landward side) and debris inside riser. FIELD_STRUCT_DESC: 54-inch corrugated metal drainage pipe through the levee, approximately 12-15 feet below the crown. Slide gate in corrugated metal pipe (CMP) riser on the waterside (WS) slope. 48-inch CMP at landside (LS) slope. This crossing crosses the levee at an angle. (54-inch pipe [HLM 2.29] authorized under Automatic Board Order (ABO) issued as Permit No. 9472, 1974 - Ballard)) [Additional Reference(s): DWR Levee Log, 1992. USACE Sacramento O&M Manual 137, August 1955, (Station 120+00)]. FS Date: 5/19/2017 1:23:34 PM

View of levee crown looking downstream at crossing. CMP riser located on WS shoulder.

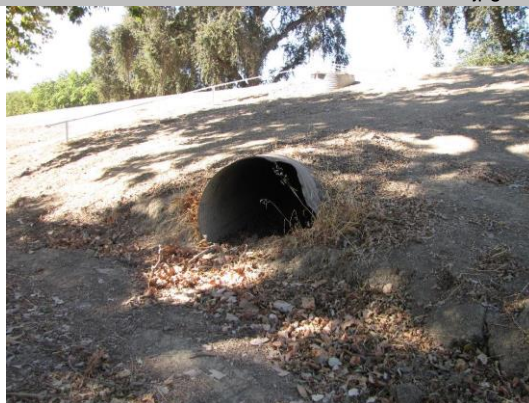
Photo 3 of 3 : UCIP_SP_2018_51854_70077.jpg

FS_ID:51854
DS_ID:16429
EP_NO: 9472
Repair Type: Non-Urgent
Crossing Status: Found
UCIP Comments: 5/3/2017 LS inlet partially plugged with soil. Some debris still present inside riser. (DWR Sutter Yard-AFreitag)10/24/2016 Debris still inside of riser.(DWR Sutter Yard-AFreitag)4/25/2016 Pipe still inside of riser and LS end plugged about 50% by soil.4/20/2015 Same as last inspection.6/18/2014 Same as last inspection.12/17/2013 Same as last inspection.7/18/2013 Same as last inspection.10/18/12 Remove debris from riser. Landward inlet is blocked by over 50%. This crossing was listed in the USACE Periodic Inspections as ID# USACE_CESPK_MA1C_2010_p_0128 for sediment build up at inlet (landward side) and debris inside riser. FIELD_STRUCT_DESC: 54-inch corrugated metal drainage pipe through the levee, approximately 12-15 feet below the crown. Slide gate in corrugated metal pipe (CMP) riser on the waterside (WS) slope. 48-inch CMP at landside (LS) slope. This crossing crosses the levee at an angle. (54-inch pipe [HLM 2.29] authorized under Automatic Board Order (ABO) issued as Permit No. 9472, 1974 - Ballard)) [Additional Reference(s): DWR Levee Log, 1992. USACE Sacramento O&M Manual 137, August 1955, (Station 120+00)].

View of outlet located at WS toe.

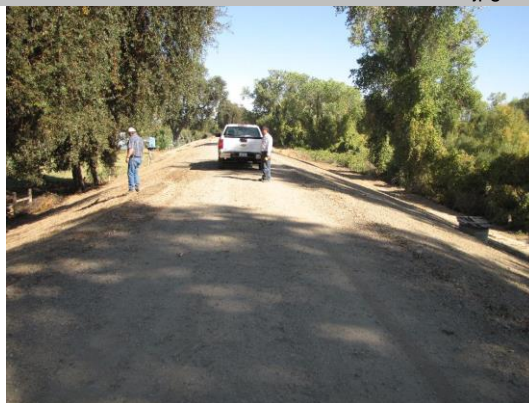
Photo 1 of 3 : UCIP_SP_2018_51855_70085.jpg

FS_ID:51855
DS_ID:16428
EP_NO: 9467
Repair Type: Non-Urgent
Crossing Status: Found
UCIP Comments: 5/3/2017 Abandoned- needs to be done so properly.
(DWR Sutter Yard- A Freitag)10/24/2016 Abandoned.(DWR Sutter Yard- A Freitag)4/25/2016 Abandoned crossing. Unable to locate any WS and LS pipe ends.4/20/2015 Same as last inspection.6/18/2014 Same as last inspection.12/17/2013 Same as last inspection.7/18/2013 Same as last inspection.10/18/2012 Only riser visible. Debris and sediment blocking gate. Gate inside riser is buried and non-functional. If crossing is abandoned, owner needs to properly abandon. This crossing was listed in the USACE Periodic Inspections as ID# USACE_CESPK_MA1C_2010_p_0132 no culvert through the levee is visible here.
FIELD_STRUCT_DESC: *ABANDONED* 24-inch corrugated metal drainage pipe through the levee, approximately 12-15 feet below the crown. Slide gate in CM pipe riser on the waterside (WS) slope. No signs of inlet visible on the landside (LS). (24-inch pipe [HLM 2.31] authorized under Automatic Board Order (ABO) issued as Permit No. 9467, 1974 - Lovell E. Spurgeon) [Additional Reference(s): DWR Levee Log, 1992. USACE Sacramento O&M Manual 137, August 1955, (Station 120+60)].

Overview of levee crown looking upstream at crossing.

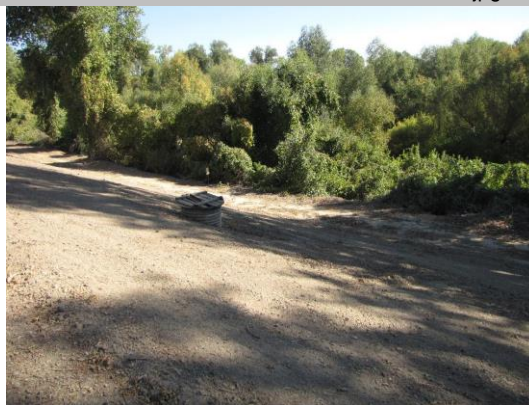
Photo 2 of 3 : UCIP_SP_2018_51855_70084.jpg

View of WS slope and toe.

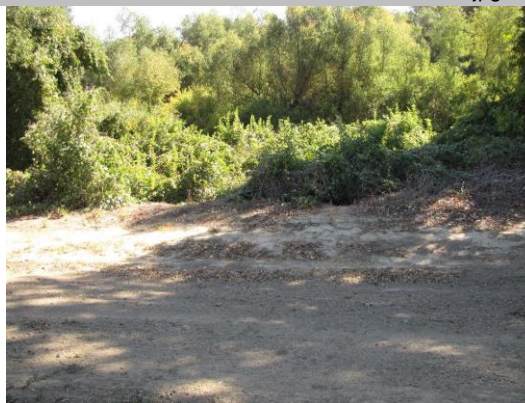
Photo 3 of 3 : UCIP_SP_2018_51855_70083.jpg

Comment Code						
Inspector Comment						
FS_ID:51855 DS_ID:16428 EP_NO: 9467 Repair Type: Non-Urgent Crossing Status: Found UCIP Comments: 5/3/2017 Abanoned- needs to be done so properly. (DWR Sutter Yard- A Freitag)10/24/2016 Abandoned.(DWR Sutter Yard- A Freitag)4/25/2016 Abandoned crossing. Unable to locate any WS and LS pipe ends.4/20/2015 Same as last inspection.6/18/2014 Same as last inspection.12/17/2013 Same as last inspection.7/18/2013 Same as last inspection.10/18/2012 Only riser visible. Debris and sediment blocking gate. Gate inside riser is buried and non-functional. If crossing is abandoned, owner needs to properly abandon. This crossing was listed in the USACE Periodic Inspections as ID# USACE_CESPK_MA1C_2010_p_0132 no culvert through the levee is visible here. FIELD_STRUCT_DESC: *ABANDONED* 24-inch corrugated metal drainage pipe through the levee, approximately 12-15 feet below the crown. Slide gate in CM pipe riser on the waterside (WS) slope. No signs of inlet visible on the landside (LS). (24-inch pipe [HLM 2.31] authorized under Automatic Board Order (ABO) issued as Permit No. 9467, 1974 - Lovell E. Spurgeon) [Additional Reference(s): DWR Levee Log, 1992. USACE Sacramento O&M Manual 137, August 1955, (Station 120+60)]. FS Date: 5/19/2017 1:48:04 PM

Unable to locate WS outlet.

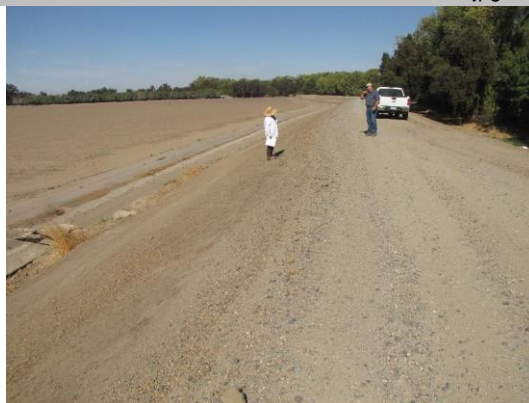
Photo 1 of 3 : UCIP_SP_2018_51859_70110.jpg

FS_ID:51859
DS_ID:16426
EP_NO: 9490
Repair Type: Non-Urgent
Crossing Status: Found
UCIP Comments: 5/3/2017 Sediment build up in WS pipe end. WS slide gate stem bent but it does not affect its operation. (DWR Sutter Yard- AFreitag)10/24/2016 WS slide gate stem is still bent.(DWR Sutter Yard- AFreitag)4/25/2016 WS slide gate is slightly bent. Rest of crossing appears to be in good condition. 4/20/2015 LS inlet still has some minor sediment build up. Needs to be cleaned.6/18/2014 Same as last inspection.12/17/2013 Same as last inspection.7/18/2013 WS slide gate looks to be in good condition but stem is slightly bent. Not sure if bend will hinder gates operation or not. LS inlet is still blocked by minor sediment build up.10/18/2012 LS pipe slightly deformed and sediment build up blocking about 30% of opening; need to check the condition of the slide gate-need photo. Metal marker down. This crossing was listed in the USACE Periodic Inspection as ID# USACE_CESPK_MA1C_2010_p_0187 for sediment build up at landward toe.

View of LS looking upstream.

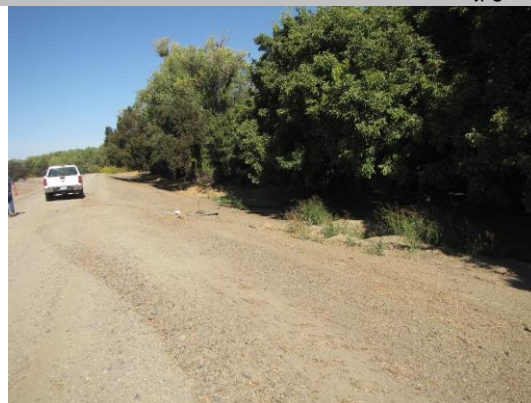
Photo 2 of 3 : UCIP_SP_2018_51859_70109.jpg

View of WS looking upstream.

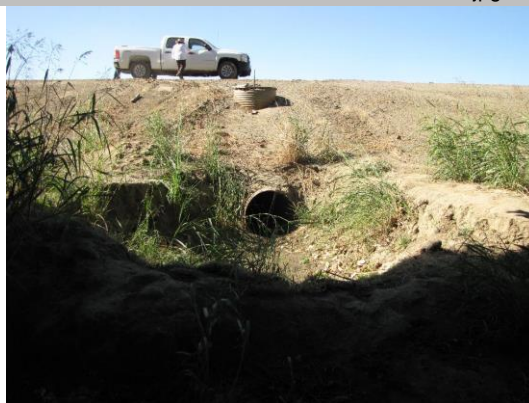
Photo 3 of 3 : UCIP_SP_2018_51859_70111.jpg

UCIP Comments: 5/3/2017 Sediment build up in WS pipe end. WS slide gate stem bent but it does not affect its operation. (DWR Sutter Yard- A Freitag) 10/24/2016 WS slide gate stem is still bent. (DWR Sutter Yard- A Freitag) 4/25/2016 WS slide gate is slightly bent. Rest of crossing appears to be in good condition. 4/20/2015 LS inlet still has some minor sediment build up. Needs to be cleaned. 6/18/2014 Same as last inspection. 12/17/2013 Same as last inspection. 7/18/2013 WS slide gate looks to be in good condition but stem is slightly bent. Not sure if bend will hinder gates operation or not. LS inlet is still blocked by minor sediment build up. 10/18/2012 LS pipe slightly deformed and sediment build up blocking about 30% of opening; need to check the condition of the slide gate-need photo. Metal marker down. This crossing was listed in the USACE Periodic Inspection as ID# USACE_CESPK_MA1C_2010_p_0187 for sediment build up at landward toe.

View of WS slope, riser with slide gate, and outlet.

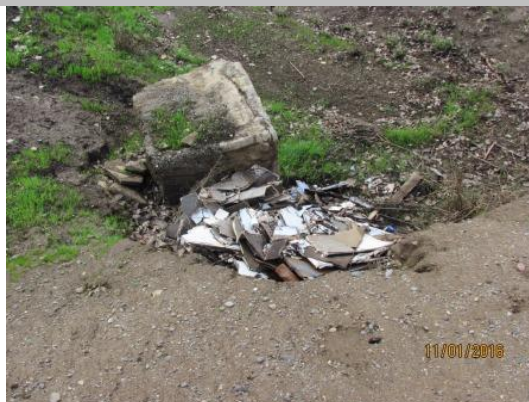
Photo 1 of 2 : SP_2018_MA0001_297_114_20180305_00033.jpg

LM Start	6.23	Rating **	M	Issue No.	114
LM End	6.23	Issue Type +	Ma	Location *	LS
Category	Earthen Levee			GPS Latitude/Longitude	
				Start	End
Item	Encroachments			39.279293 °	39.279293 °
				-122.022537 °	-122.022537 °
DWR ID	DWR_MA0001_01_f_2016_114				
Comment Code					
DE : Debris					
Inspector Comment					
Debris found along landside toe on both sides of the ramp (dry wall debris used for erosion control and brick/concrete debris on landside toe.)

View of the dry wall debris used for erosion control along the downstream side of the ramp.

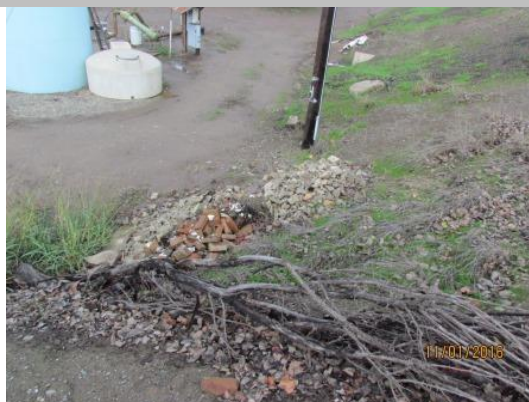
Photo 2 of 2 : SP_2018_MA0001_297_114_20180305_00034.jpg

View of the bricks and concrete debris along the upstream side of the ramp.

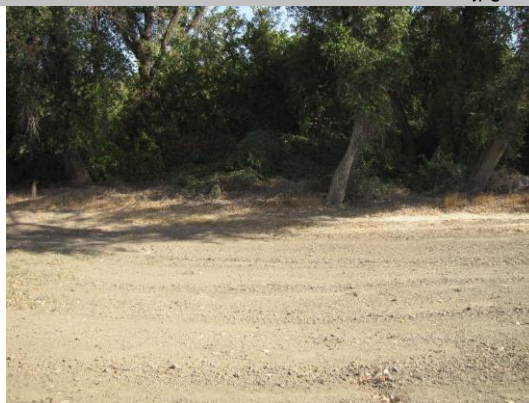
Photo 1 of 3 : UCIP_SP_2018_51874_70181.jpg

FS_ID:51874
DS_ID:16425
EP_NO: N/A
Repair Type: Non-Urgent
Crossing Status: Found
UCIP Comments: 5/3/2017 Abandoned- needs to be done properly.
(DWR Sutter Yard- A Freitag)10/24/2016 Abandoned(DWR Sutter Yard- A Freitag)4/25/2016 Abandoned crossing.4/20/2015 Same as last inspection.6/23/2014 Same as last inspection.12/17/2013 Same as last inspection.7/18/2013 Same as last inspection.10/19/2012 Need to be properly abandoned concrete structure; plate covers concrete box; Concrete headwall damaged. This crossing was listed in the USACE Periodic Inspection as ID# USACE_CESPK_MA1C_2010_p_0262 for damage to concrete structure (vertical 2 inch wide cracks and spalling visible).
FIELD_STRUCT_DESC: *ABANDONED* 72-inch corrugated metal (precast concrete) drainage pipe through the levee at an unknown depth below the crown. Structure is blocked on the waterside (WS) end with 3-foot concrete plug installed in 1980. Slide gate in concrete well on the landside (LS) shoulder. Concrete headwall at both toes. WS headwall not found. [Additional Reference(s): DWR Levee Log, 1992. USACE Sacramento O&M Manual 137, August 1955, (Station 339+74)].

View of WS no structure features visible.

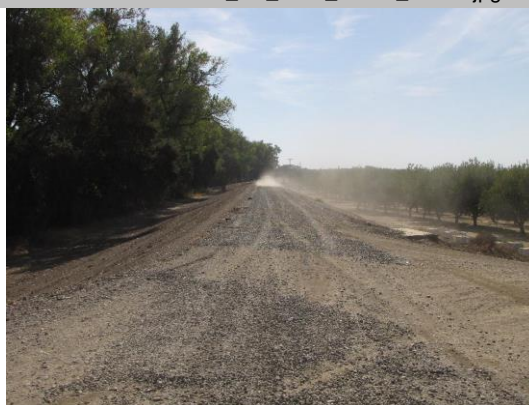
Photo 2 of 3 : UCIP_SP_2018_51874_70180.jpg

Overview of levee crown looking downstream at crossing.

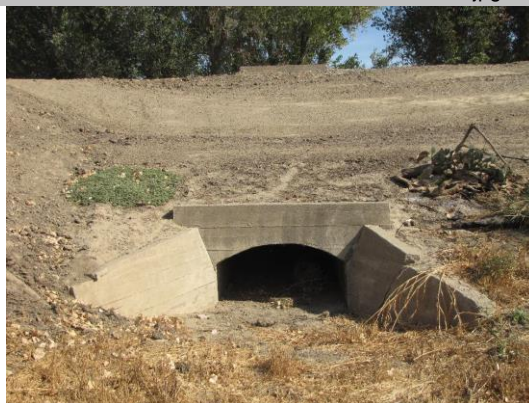
Photo 3 of 3 : UCIP_SP_2018_51874_70179.jpg

FS_ID:51874
DS_ID:16425
EP_NO: N/A
Repair Type: Non-Urgent
Crossing Status: Found
UCIP Comments: 5/3/2017 Abandoned- needs to be done properly.
(DWR Sutter Yard- A Freitag)10/24/2016 Abandoned(DWR Sutter Yard- A Freitag)4/25/2016 Abandoned crossing.4/20/2015 Same as last inspection.6/23/2014 Same as last inspection.12/17/2013 Same as last inspection.7/18/2013 Same as last inspection.10/19/2012 Need to be properly abandoned concrete structure; plate covers concrete box; Concrete headwall damaged. This crossing was listed in the USACE Periodic Inspection as ID# USACE_CESPK_MA1C_2010_p_0262 for damage to concrete structure (vertical 2 inch wide cracks and spalling visible).
FIELD_STRUCT_DESC: *ABANDONED* 72-inch corrugated metal (precast concrete) drainage pipe through the levee at an unknown depth below the crown. Structure is blocked on the waterside (WS) end with 3-foot concrete plug installed in 1980. Slide gate in concrete well on the landside (LS) shoulder. Concrete headwall at both toes. WS headwall not found. [Additional Reference(s): DWR Levee Log, 1992. USACE Sacramento O&M Manual 137, August 1955, (Station 339+74)].

View of structure located in LS.

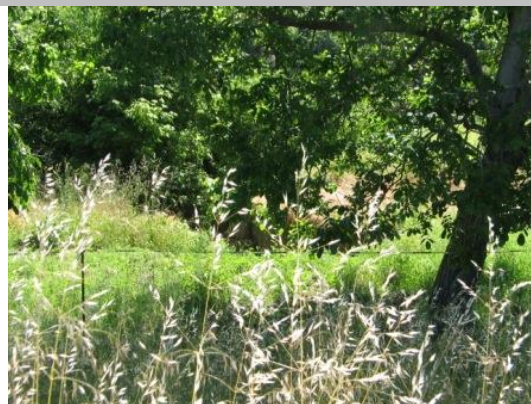
Photo 1 of 1 : SP_2018_MA0001_297_18_20180305_00009.jpg

LM Start	10.13	Rating **	M	Issue No.	18
LM End	10.13	Issue Type +	Ma	Location *	WS
Category	Earthen Levee			GPS Latitude/Longitude	
				Start	End
Item	Erosion / Bank Caving			39.328697 °	39.328697 °
				-122.029262 °	-122.029262 °
DWR ID	DWR_MA0001_01_s _ 2012_18				
Comment Code					
E1 : Note and monitor erosion site.					
Inspector Comment					
Monitor the erosion site.

View of the erosion along the waterside of the levee.

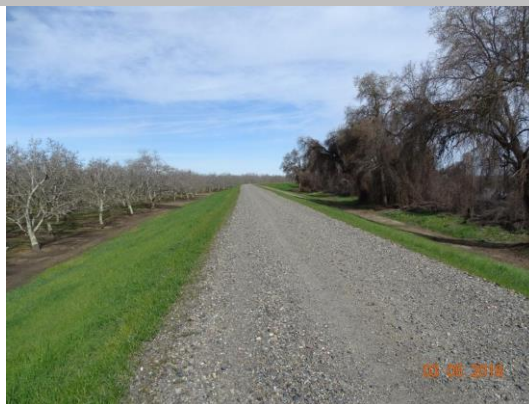
Photo 1 of 1 : SP_2018_MA0001_297_68_20180312_00150.jpg

LM Start	10.52	Rating **	A	Issue No.	68
LM End	10.52	Issue Type +	Ma	Location *	LS
Category	Earthen Levee			GPS Latitude/Longitude	
				Start	End
Item	Vegetation			39.333925 °	39.333925 °
				-122.031355 °	-122.031355 °
DWR ID	DWR_MA0001_01_s _ 2018_68				
Comment Code					
V1 : Control annual grass and weeds on the levee slopes and easements.					
Inspector Comment					
There is native grasses on both slopes.

View of native grasses on both slopes.

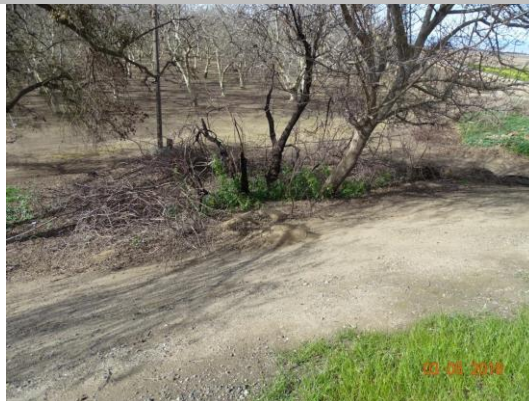
Photo 1 of 1 : SP_2018_MA0001_297_69_20180312_00151.jpg

LM Start	11.01	Rating **	M	Issue No.	69
LM End	11.01	Issue Type +	Ma	Location *	LS
Category	Earthen Levee			GPS Latitude/Longitude	
				Start	End
Item	Animal Control			39.340803 °	39.340803 °
				-122.032868 °	-122.032868 °
DWR ID	DWR_MA0001_01_s_2018_69				
Comment Code					
A3 : No rodents visible, but rodent burrows visible; need to backfill and compact or grout burrows.					
Inspector Comment					
Repair the rodent holes along the landside slope.

View of the rodent holes along the landside slope.

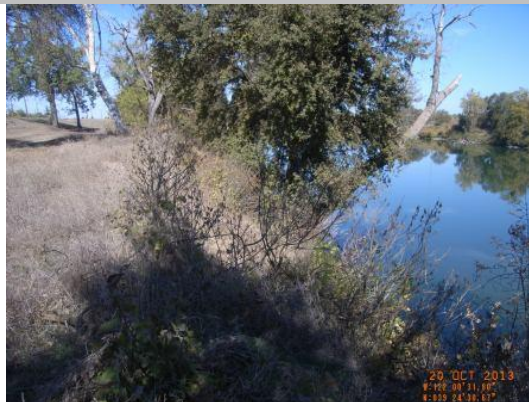
Photo 1 of 2 : SP_2018_MA0001_297_9_20180305_00006.jpg

LM Start	16.35	Rating **	A/W	Issue No.	9
LM End	16.58	Issue Type +	Ma	Location *	WS
Category	Supplemental			GPS Latitude/Longitude	
				Start	End
Item	2015 USACE Erosion Survey, DRAFT			39.407837 °	39.411111 °
				-122.008763 °	-122.009238 °
DWR ID	DWR_MA0001_01_s_2016_9				
Comment Code					
Inspector Comment					
Erosion site added in 1997 and removed in 2005. 2009 - Site added back in, hard toe with slow moving erosion. Potential geotechnical failure. 2011 - Site extended downstream. 2015: Last observed in 2013. [2015 Site ID: SAC_164-3_R]

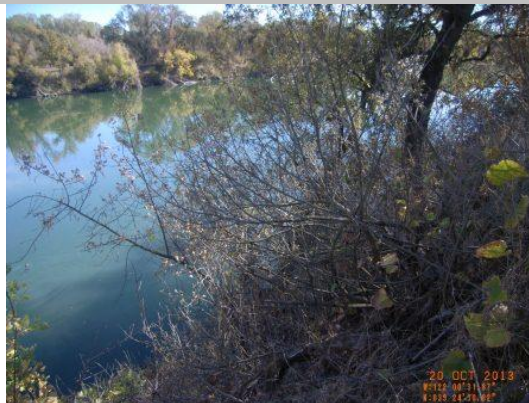
Photo 2 of 2 : SP_2018_MA0001_297_9_20180305_00007.jpg

LM Start	16.35	Rating **	A/W	Issue No.	9 (cont)
LM End	16.58	Issue Type +	Ma	Location *	WS
Category	Supplemental			GPS Latitude/Longitude	
				Start	End
Item	2015 USACE Erosion Survey, DRAFT			39.407837 °	39.411111 °
				-122.008763 °	-122.009238 °
DWR ID	DWR_MA0001_01_s _ 2016_9				
Comment Code					
Inspector Comment					
Erosion site added in 1997 and removed in 2005. 2009 - Site added back in, hard toe with slow moving erosion. Potential geotechnical failure. 2011 - Site extended downstream. 2015: Last observed in 2013. [2015 Site ID: SAC_164-3_R]
